# GEOTECHNICAL DESIGN OF THE TE APITI WIND FARM

Alexei Murashev, Robert Davey, Greg Cook

## ABSTRACT

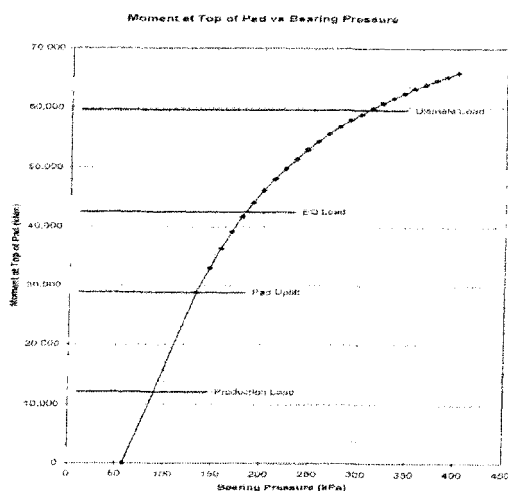
Figure 5. Maximum bearing pressure as a function of the bending moment

quirements are aimed at limiting the size of the plastic zones in the soil beneath the pad and achieving adequate serviceability behavior of conventional structure foundations. The loading on the turbine foundations is substantially different from that for conventional structure foundations (e.g. lower gravity load due to light weight of the turbine, high load eccentricity due to light weight of the turbine and high extreme wind loads). The load eccentricity under high wind loads can be substantial, resulting in stress concentration under the edge of the pad. The width of the equivalent footing changes from one loading case to another as a result of changes in the eccentricity associated with different loading cases. The loss of basal contact and stress concentration under the edge of the pad were carefully considered. Under the production load, the pad remained in contact with the soil. For infrequent seismic and ultimate wind loads, loss of basal contact was considered to be acceptable. The maximum bearing pressure under the pad as a function of the bending moment applied to the top of the pad is

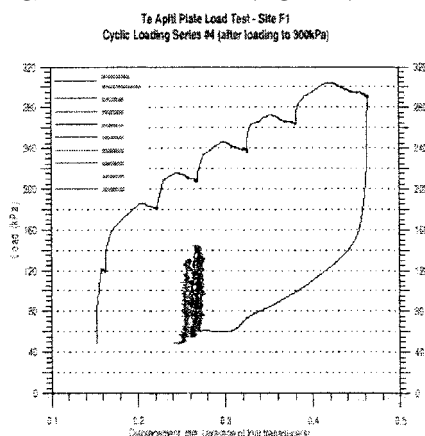
Figure 7. Plate load test data, hard siltstone

The turbine manufacturers specified the minimum rocking stiffness of the pad foundation required to comply with the parameters used in their load modeling. The rocking stiffness of the pad foundation is governed by the size of the pad, soil stiffness, rate of loading, size of the zone of plastic deformation in the soil, soil potential for degradation of strength and stiffness. Dynamic plate load tests in the field were undertaken to confirm the soil stiffness. The plate load test data indicated that the hard siltstone (Figure 7) demonstrated essentially elastic behavior under cyclic loading, while the soft silt (Figure 8) had a potential

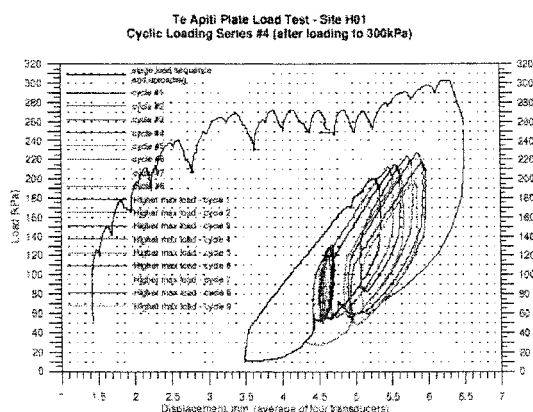
Figure 8. Plate load test data, soft silt

for degradation of stiffness. The rocking stiffness of the pads founded on soft silt during the initial load cycles would still be within the required limits, but accumulation of plastic deformation in the plastic zone under the pad foundation in further loading cycles could result in reduced rocking stiffness of the foundation-soil base system. Also, for some soft sites the ultimate bearing capacity condition could not be satisfied. It was therefore considered necessary to reduce the size of the zone of plastic deformation and the stress level in the soft silt to ensure the elastic response of the soil governs the rocking stiffness, and ensuring the ultimate bearing capacity remains adequate. The methodology adopted for the soft sites is described in
